Tree Report

Liquidamber Trees

Station St
Bangalow

Report compiled by
Northern Tree Care
Burringbar
22nd November, 2011.

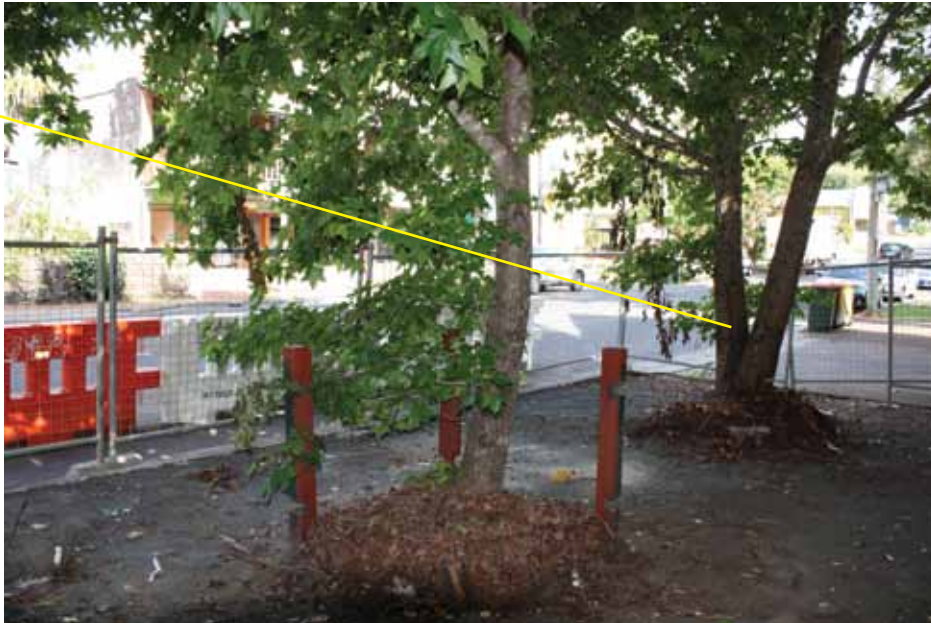
Plate 1

This tree has a co-dominant leader from the base of the tree. The junction between the leaders has included bark. There is no sign of decay or borers near the junction. There is a small bump or cut injury at the base of the tree. There are some previous pruning cuts and stubs have been left on the tree.

Tree # 1

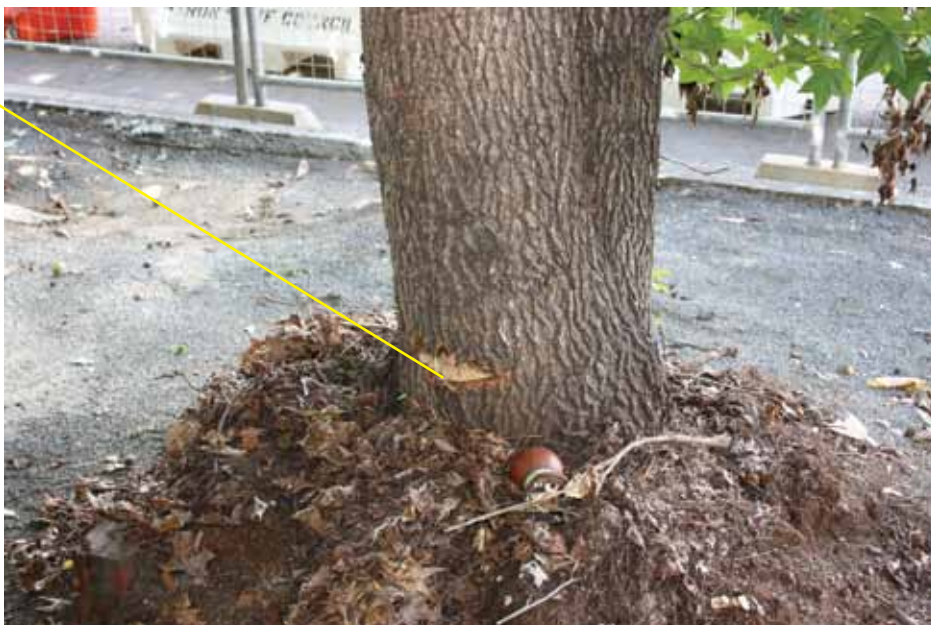
Plate 2

Tree # 1
Bump injury

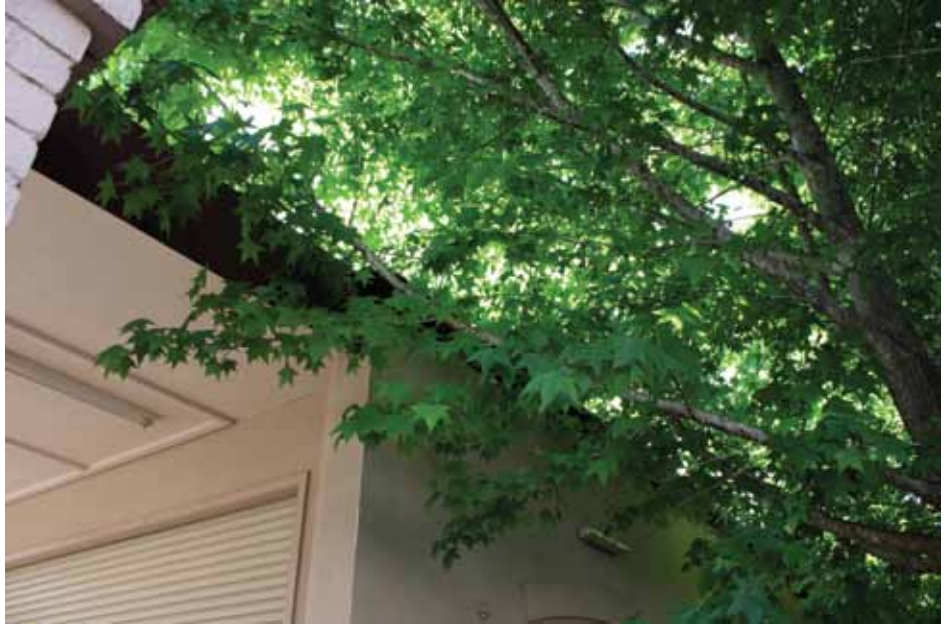
Plate 3

There are some branches overhanging or touching the adjacent building.

Tree # 1

Tree branches are touching the building.

The tree branches that are encroaching on the building should be pruned off to give at least 1 metre clearance to the building. The pruning should be carried out by an arborist qualified to at least Certificate 3 in Arboriculture. The pruning should be carried out in accordance with the recommendations of the Australian Standard AS 4373 - 2007 Pruning of amenity trees.

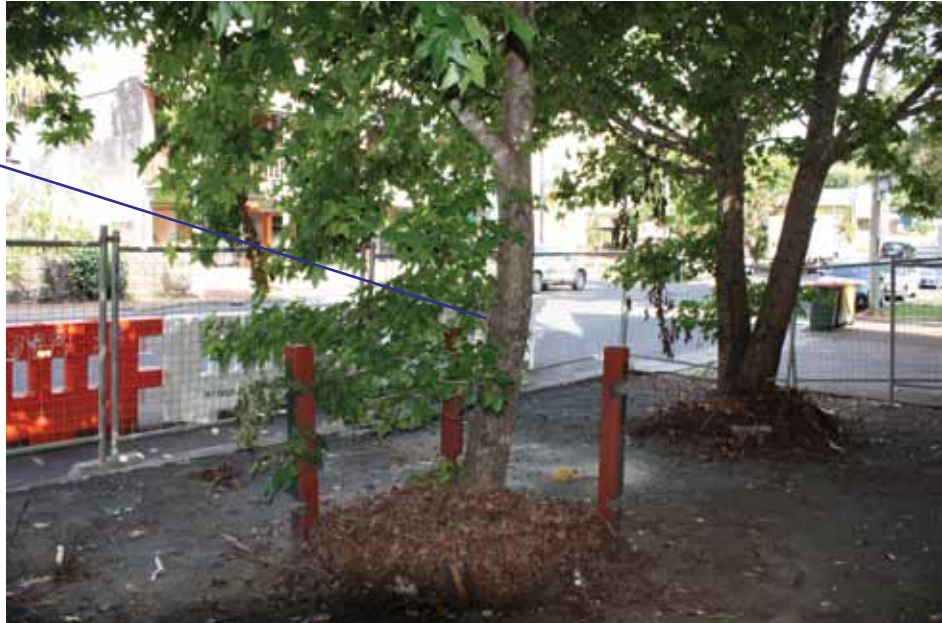
Plate 5

This is the smallest of the three trees. It has been suppressed by the two adjoining trees. It is in good condition and has a single leader trunk.

Some of the branches from this tree are growing within 1 metre of the building.

Tree # 2

Trees in groups will naturally suppress weaker specimens to make room for the increasing size of the surviving trees. Consideration should be given to the removal of tree # 2. This would decrease the competition for space both above and below the ground. Because it is following the trees own natural growing habit it would not detract from the amenity of these trees. It is likely to improve the long term (10 plus years) viability of the remaining trees.

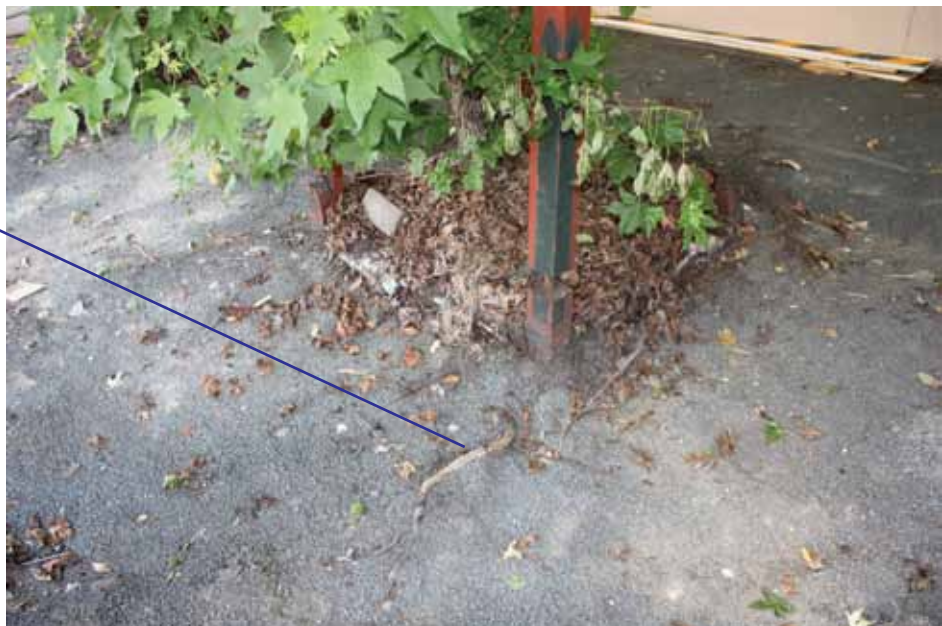
Plate 6

There is 1 root growing on the surface of the ground the the south west of the tree. It approximately 50mm in diameter.

Tree # 2

Surface root

These trees have been assessed as important trees. They are also causing damage to the footpath pavers in their immediate vicinity. In order to strike a balance between the need to maintain the pavement in a safe condition and the retention of the streetscape, it is recommended that the roots causing the pavers lift be removed and the paving relaid. The roots causing the damage should be cut with a saw or an axe. The roots should be cut back to the raised area around the base of the tree and that raised area be maintained.

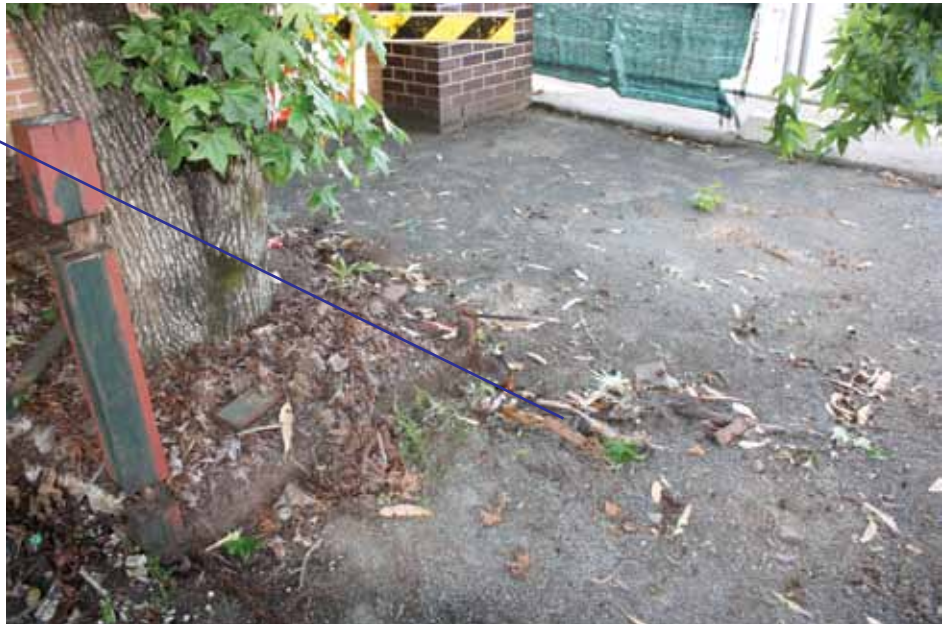
Plate 7

There are two major surface roots growing from this tree. One to the north is approximately 100mm in diameter and one to the south west is approximately 75mm in diameter.

Tree # 3

Tree roots to the south west.

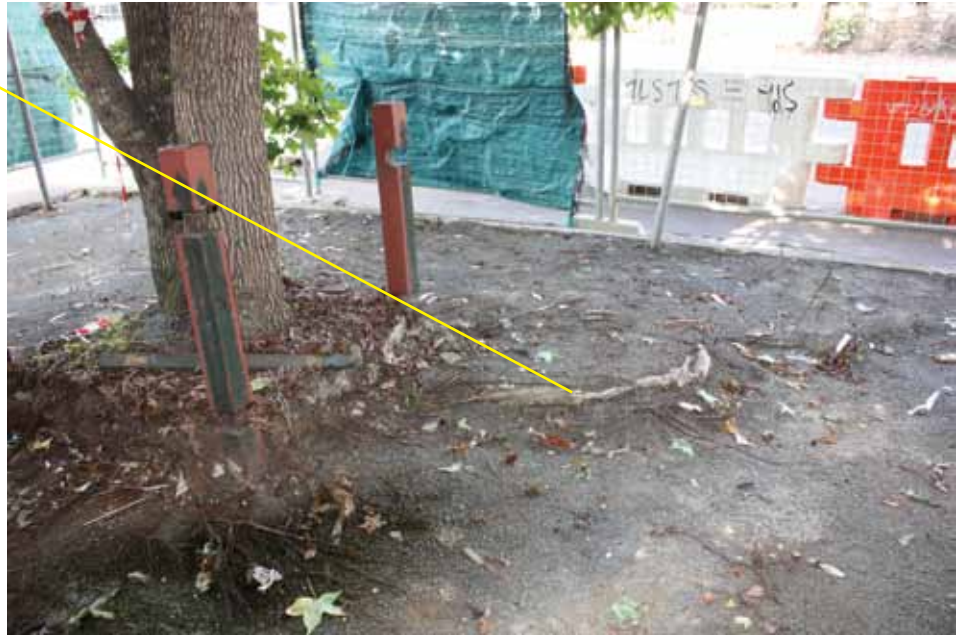
Plate 8

Tree # 3

Tree root to the north.

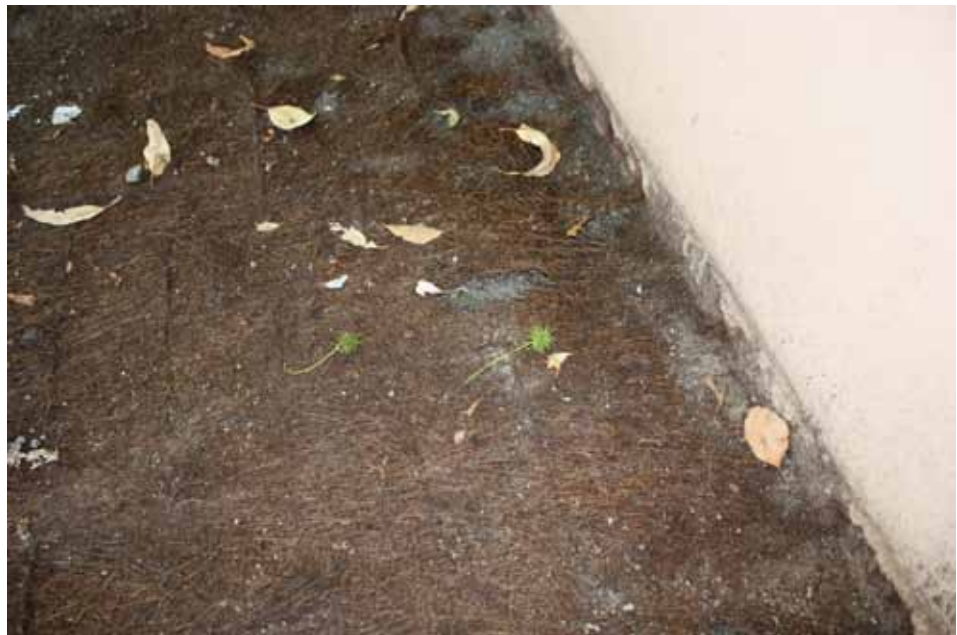
Plate 9

There is also some mat roots east to the building. These roots are small in diameter. The mat of roots does reach the building but because the roots are fine it is not considered likely they would cause any damage to the building. The mat roots have lifted the pavers however.

Tree # 3

Root mat.

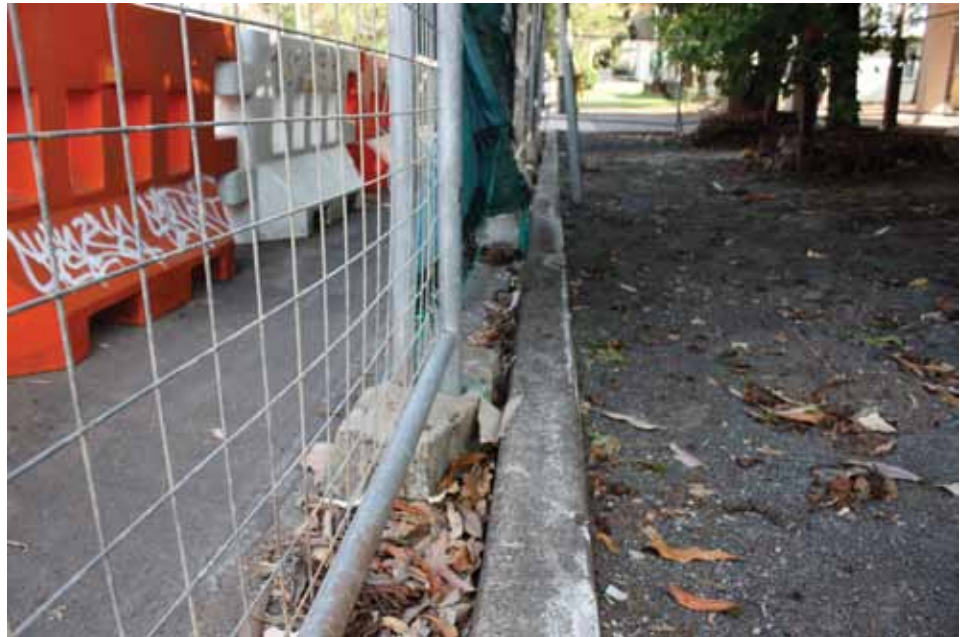
Plate 10

The trees roots do not appear to have damaged the concrete curb or the building structure.

Concrete kerb

It is unlikely the roots will damage the building or the kerb in the medium term (5 ~ 10 years). Protection to the building should be provided by the installation of a root barrier, provided this does not interfere with any underground services. The root barrier should be installed to approximately 1 metre depth as close to the building as practicable (see Attachment 2. Root Barrier Plan).

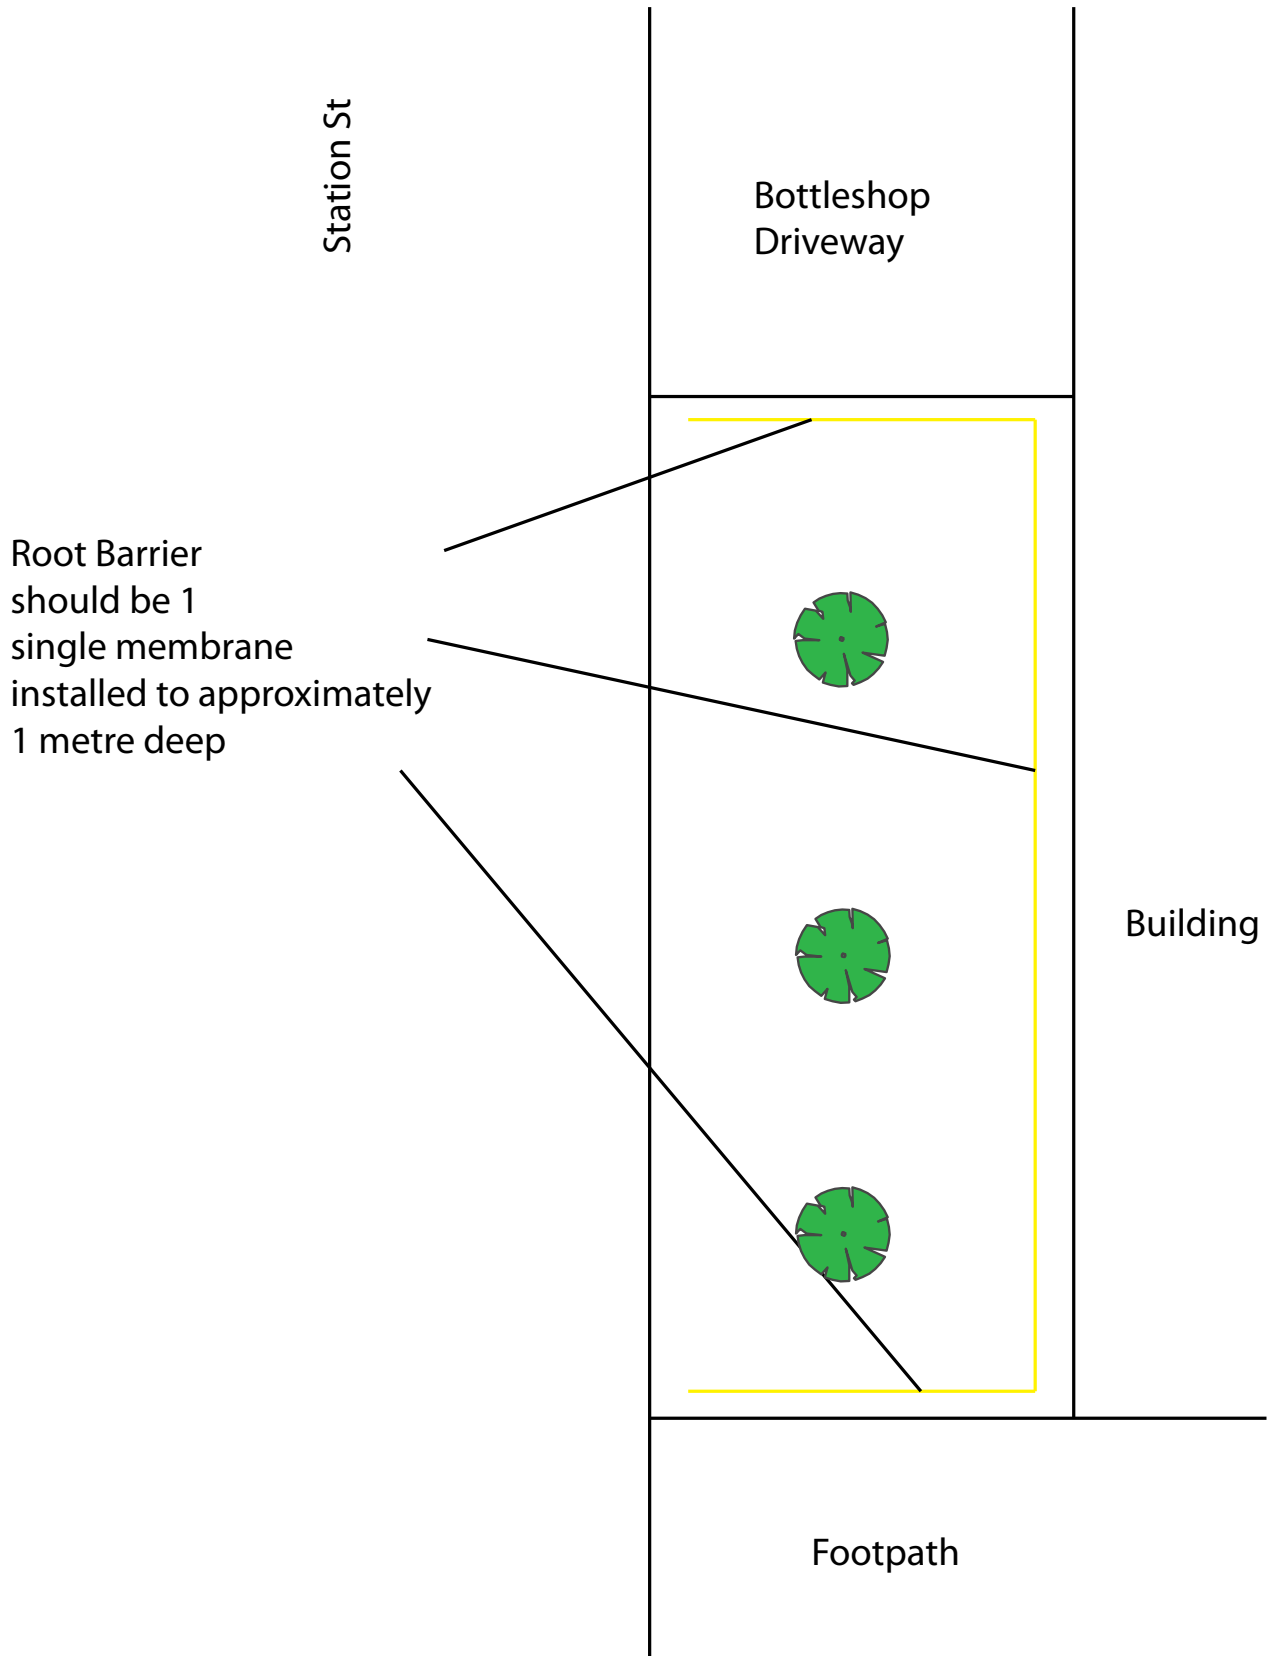
10. Attachment 2. Root Barrier Plan

Root Barrier
for Liquidamber trees in
Bangalow.
