Tree Report

Liquidamber Trees

Station St
Bangalow

Report compiled by
Northern Tree Care
Burringbar
22nd November, 2011.

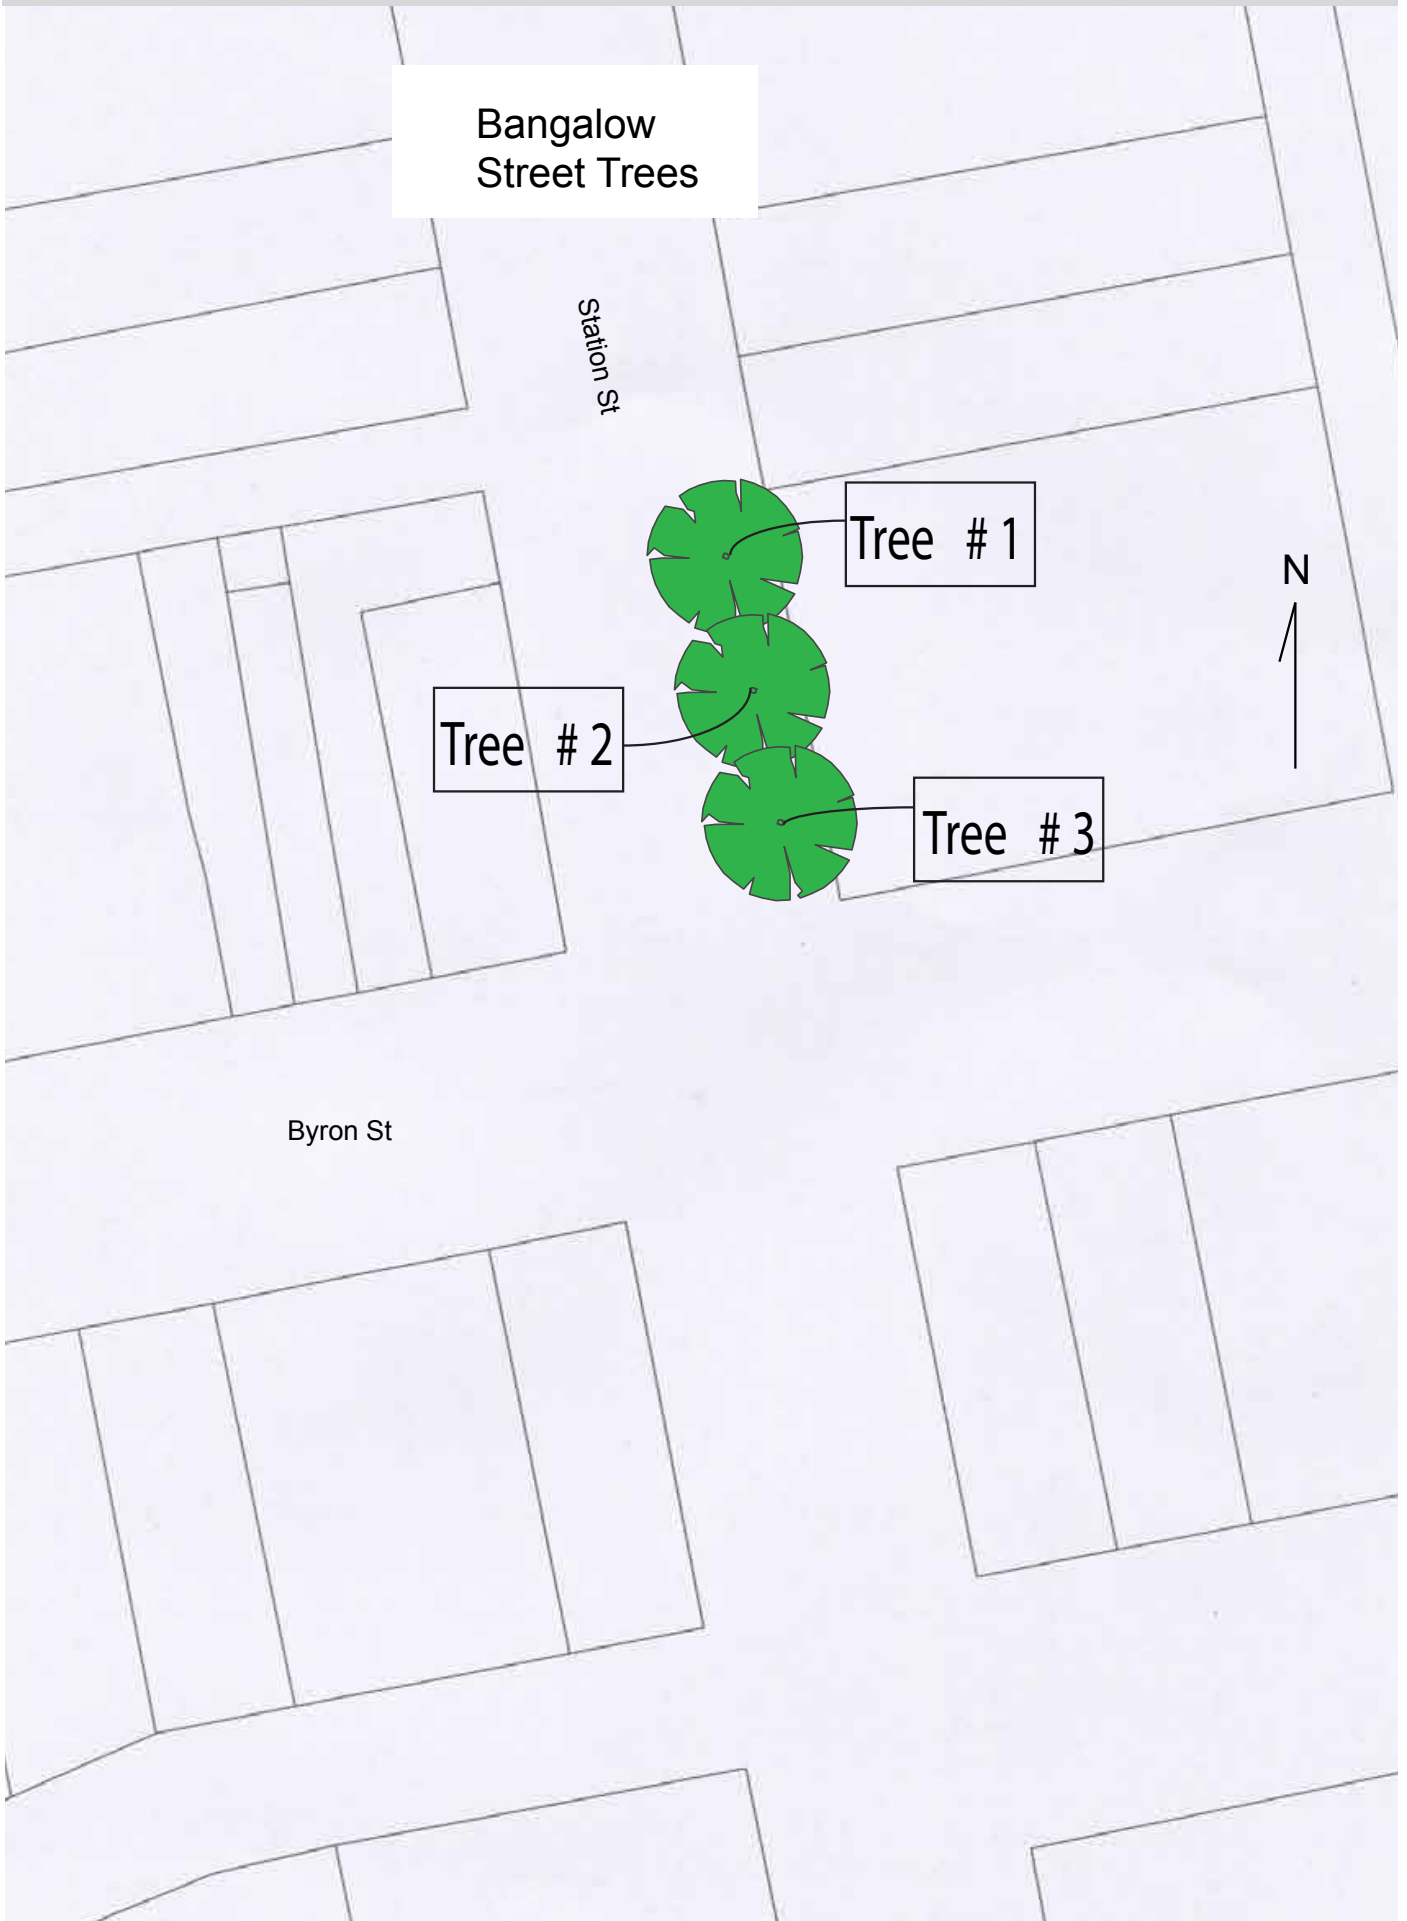
10. Attachment 2. Root Barrier Plan

Root Barrier
for Liquidamber trees in
Bangalow.

Council should install a root barrier to protect the building.
